MEASUREMENTS OF THE FLYING QUALITIES OF

A HAWKER HURRICANE AIRPLANE

MEMORANDUM REPORT

Army Air Forces, Materiel Command

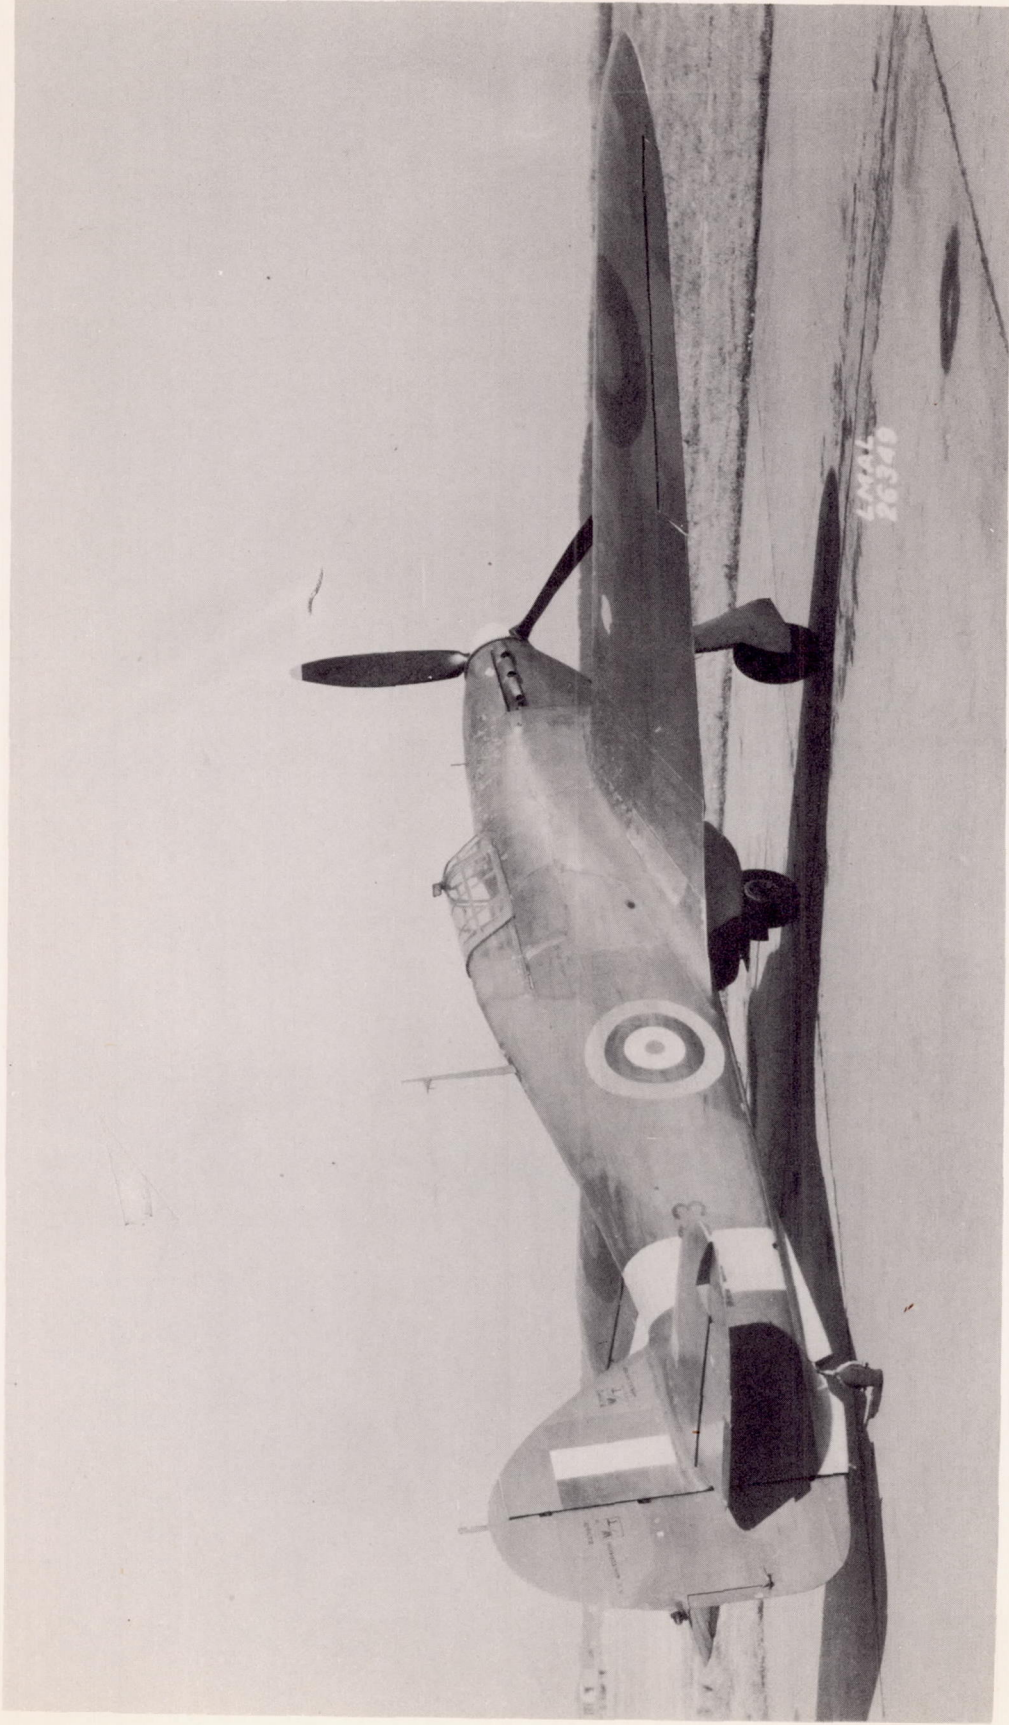
Figure 3.- Three-quarter rear view of the Hawker Hurricane airplane.

The Hawker Hurricane is a single-place, single-engine, low-wing, cantilever monoplane with retractable landing gear and partial-span split flaps (figs. 1, 2, 3, and 4). The general specifications of the airplane are as follows:
